Where we are Today: Cured in Place Pipe Lining (CIPP) Chemical Emissions and Safety

Andrew J. Whelton, Ph.D.

Lyles School of Civil Engineering
Environmental & Ecological Engineering
awhelton@purdue.edu

September 2019

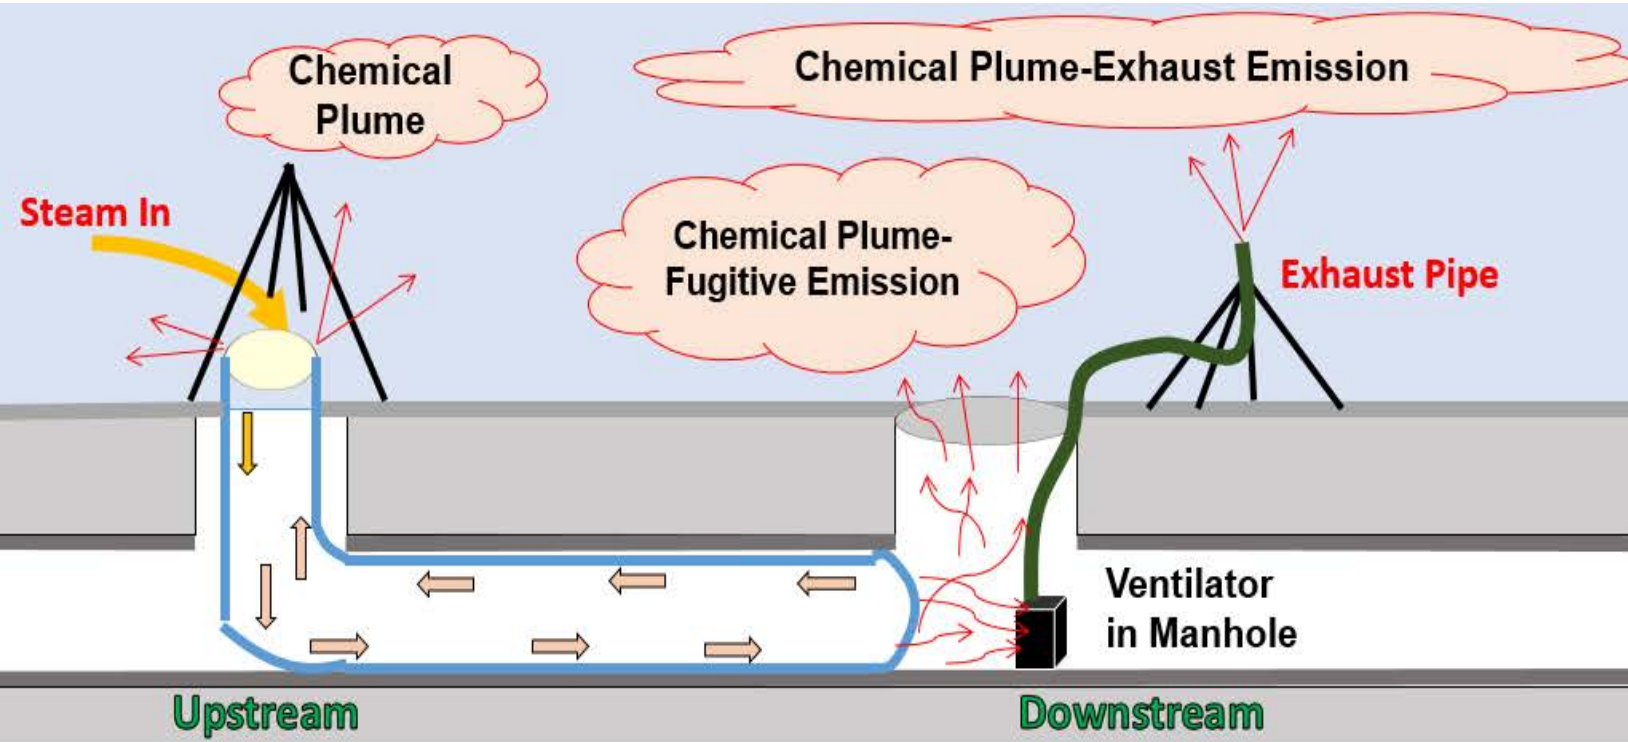
OUTDOOR PLASTIC (CIPP) MANUFACTURING SITES, CHEMICALS ARE CREATED

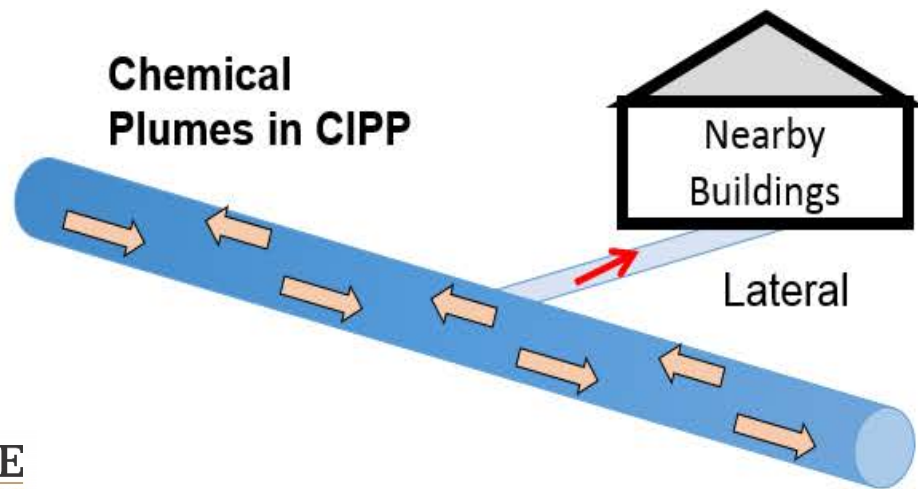
Chemical Plumes Generated by CIPP can Escape the Pipe Being Repaired

Chemical plumes can be discharged into nearby areas

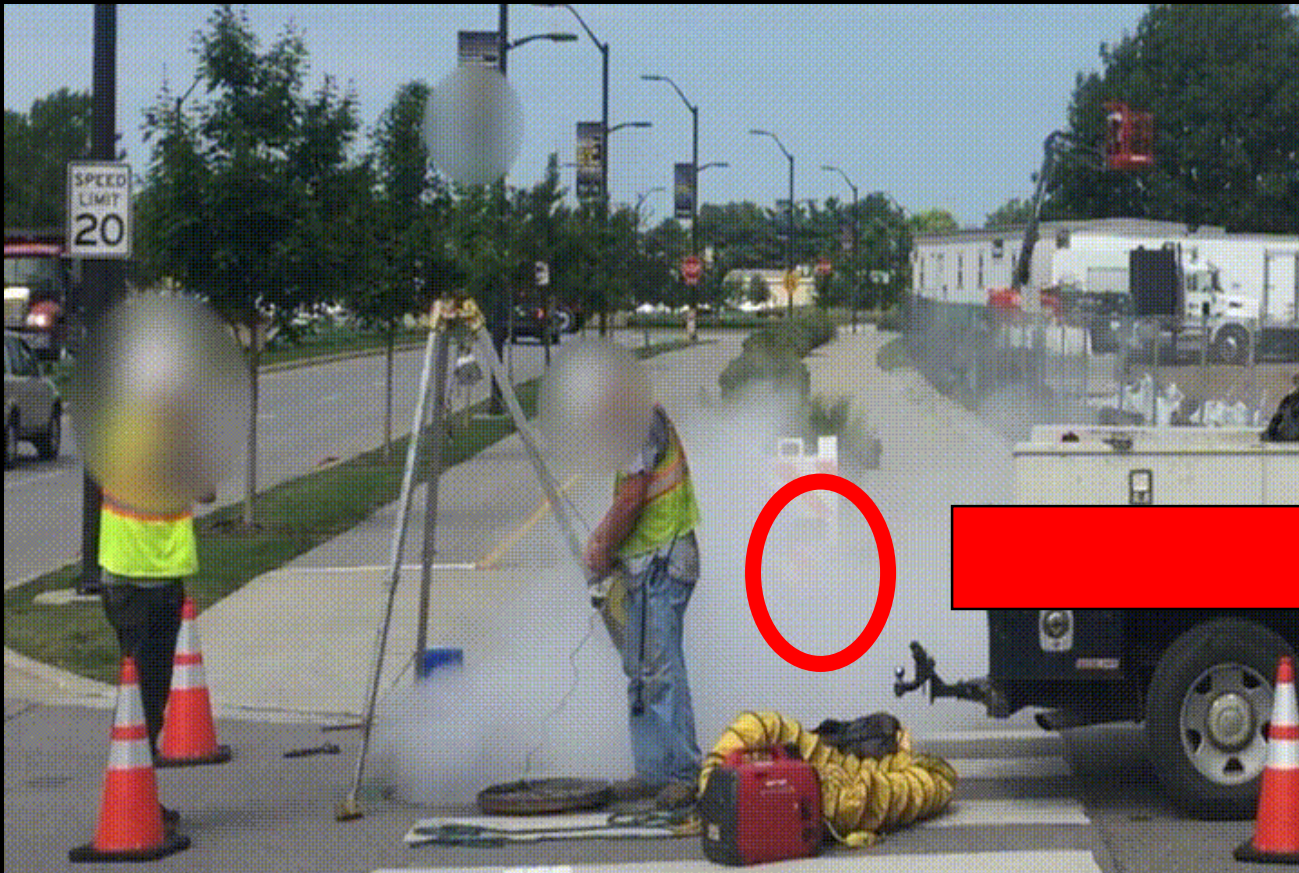
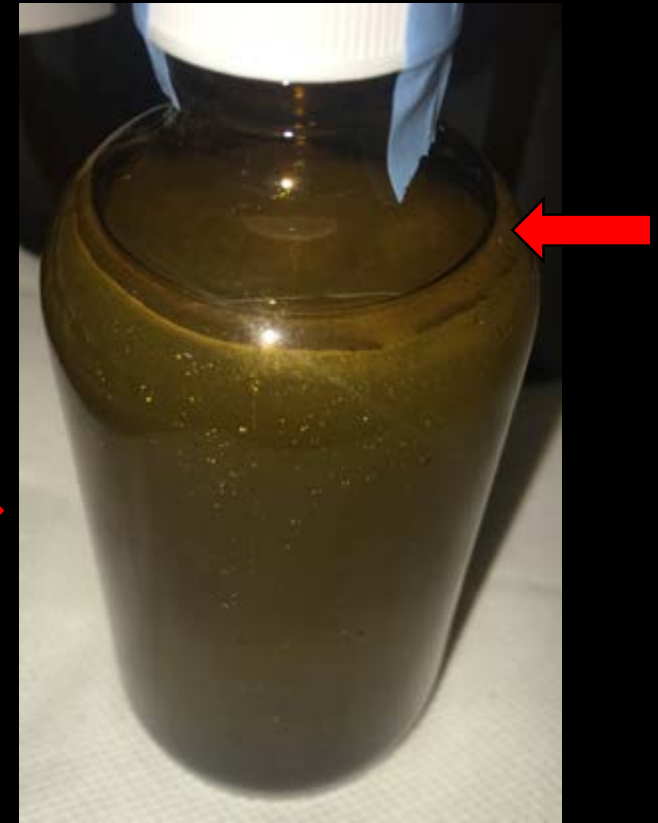
This is a Multiphase Chemical Mixture, NOT Steam
(particulates, droplets, partially cured resin, etc.)

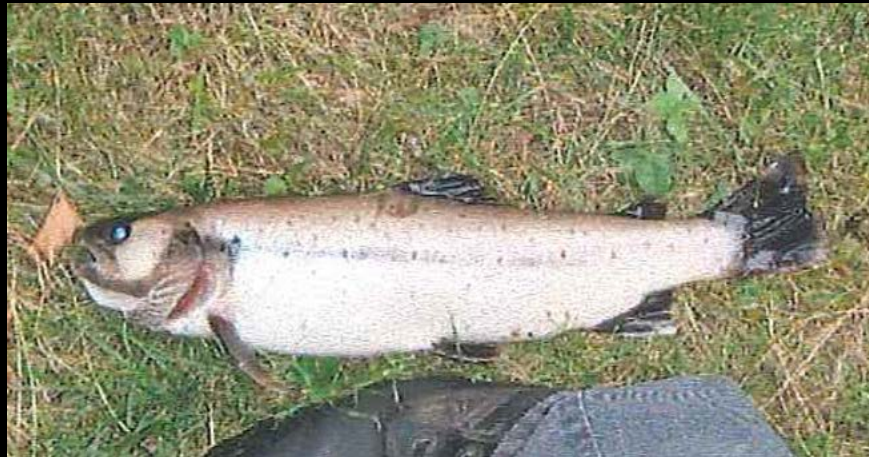
August 2019 in Carlisle, PA

Fish kill (200+) associated with CIPP contractors

Styrene found, temperature not high
